Impacts of tephra fall on buildings from the
2017-2018 eruption of Manaro Voui volcano,
Ambae Island, Vanuatu

A thesis

Master of Science in Geology

The University of Canterbury

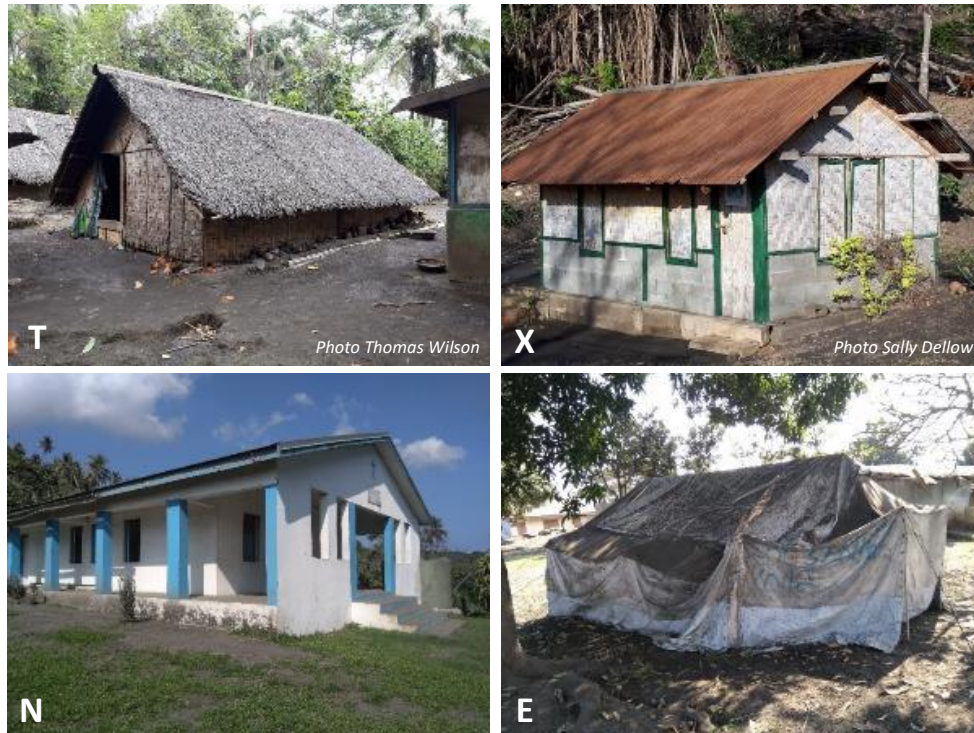
Figure 4.1 Four broad building construction typologies present on Ambae at the time of the 2017/18 eruption period; Traditional (T), Hybrid construction (X), Non-traditional construction (N) and Temporary (E).

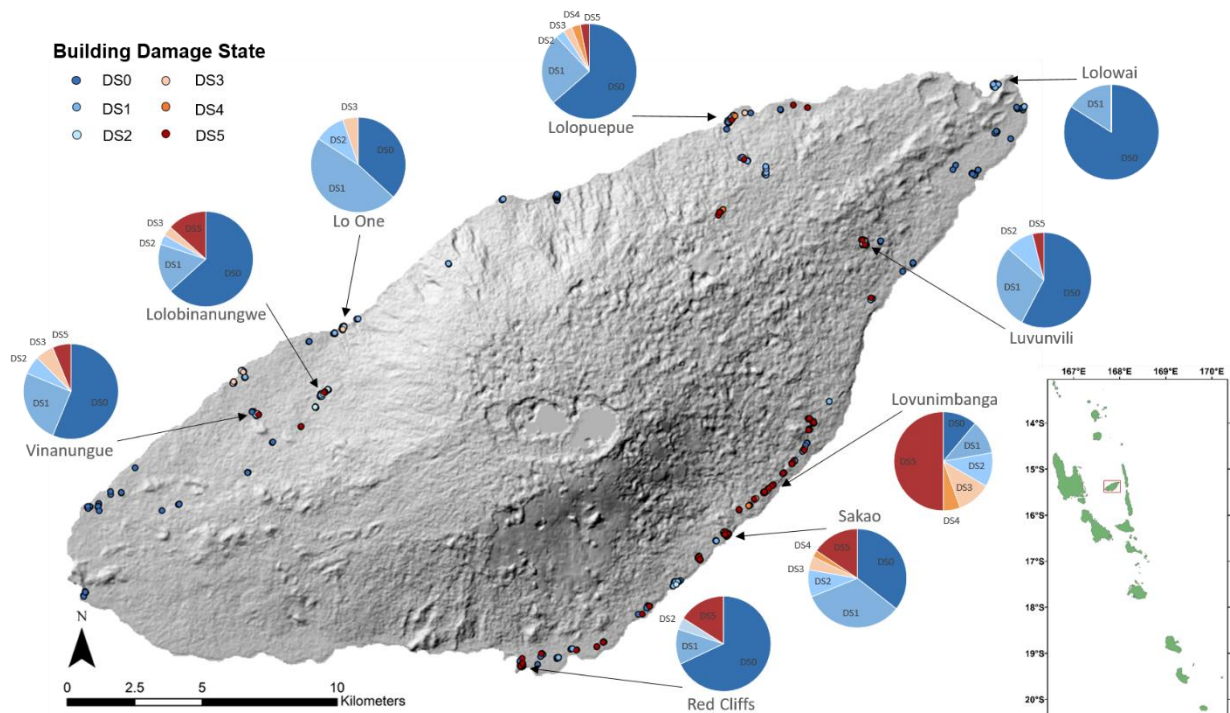
Figure 4.4 Distribution of building damage across Ambae and in specific villages that had all buildings recorded in the two photographic surveys.

Blong (2003) recorded a positive relationship between increased hazard intensity (ash loading) and increased level of building damage at Rabaul. This relationship is also evident in other building fragility curve studies (e.g. Pomonis et al., 1999; Jenkins et al., 2014; Maqsood et al., 2014). Hybrid buildings did show a weak relationship between increasing tephra thickness and building damage (Figure 4.10). However, traditional and non-traditional buildings sampled on Ambae did not show a clear relationship between increasing tephra thickness and building damage (Figure 4.5 and Figure 4.8). This suggests there were other building characteristics, not captured in the photographic survey, which contributed to the distribution of damage. As highlighted by Blong (2003) the threshold at which a building collapsed, or sustains damage may be lower than what was recorded in the field (as tephra may have continued to accumulate after collapse had occurred). However, there was insufficient time in the field to measure the tephra deposit on each building to determine the threshold at which it collapsed or sustained damage.

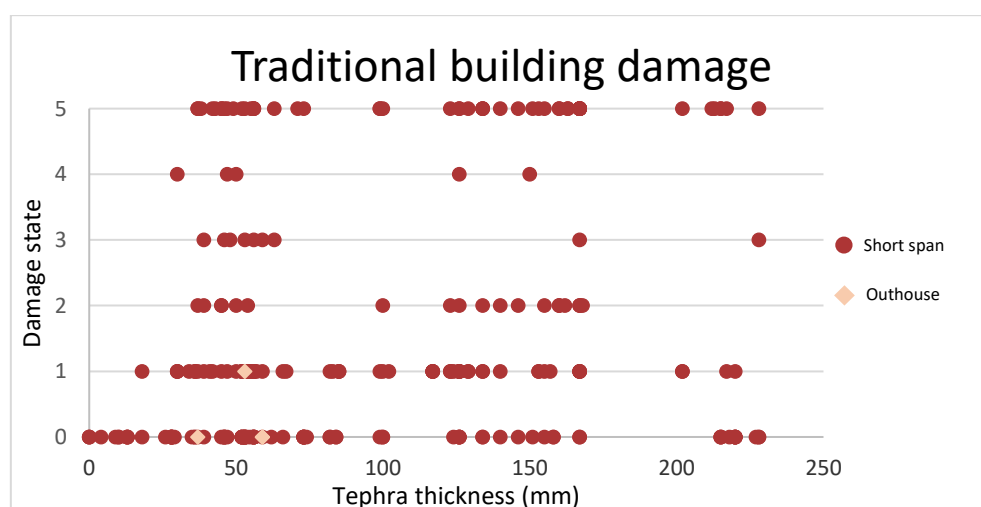
Figure 4.5 Traditional building damage distribution on Ambae, Vanuatu

Traditional buildings were observed to be the most vulnerable building construction typology present on Ambae. Of the surveyed buildings that sustained any damage from tephra fall (DS1-5) 65% (n=163) were traditional buildings, and of the 65 DS5 buildings, 54 (83%) were traditional. The lowest threshold observed to generate partial (DS4) and complete (DS5) collapse in a traditional roof structure was 32 mm and 38 mm of tephra, respectively (Figure 4.5). Despite this low threshold, traditional buildings were observed to have sustained no damage (DS0) when exposed to tephra thicknesses in excess of 200 mm (Figure 4.5). This further reinforces the idea that there is a building characteristic unable captured in the photographic survey that is contributing to a traditional building's vulnerability from tephra fall. This is shown in Figure 4.6 where there are two comparable traditional buildings next to each other, but one has completely collapsed (DS5) while the other shows no evidence of any damage from tephra fall.

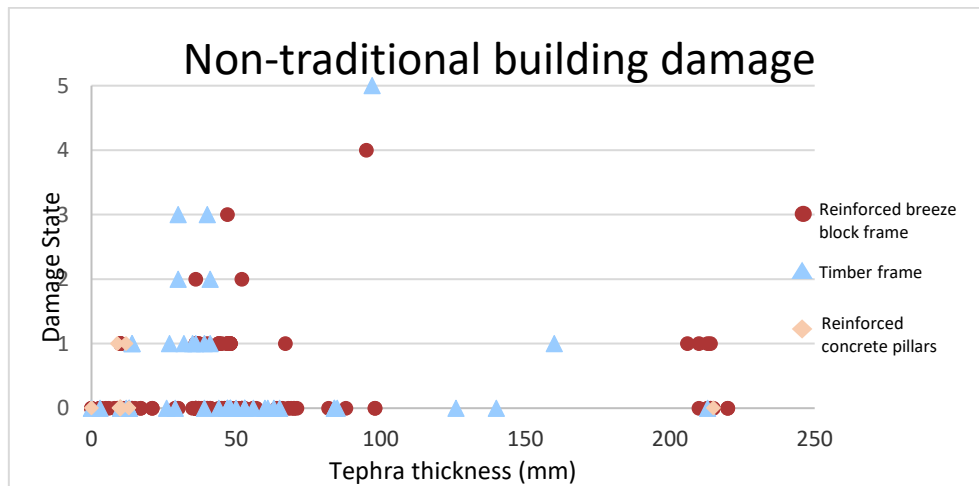
Figure 4.8 Non-traditional building damage distribution on Ambae, Vanuatu

The most common damage non-traditional buildings sustained was gutter collapse or failure of the corrugated sheet metal roof covers. Of the non-traditional buildings surveyed, only 20% showed signs of damage (DS1-5) following the March/April and July 2018 tephra falls. Of the 20% that sustained damage from tephra fall, 78% (n=33) had minor, non-structural damage (DS1) (Table 4.4) with approximately three-quarters (n=24) only exhibiting damage to gutters alone. Like the damage distribution for traditional buildings, non-traditional building damage distribution shows buildings exposed to large tephra thicknesses with no evidence of damage, but also buildings that exhibit

structural damage at much smaller tephra thicknesses (Figure 4.8). Some non-traditional buildings that sustained structural damage at thinner tephra thicknesses showed evidence of a poor pre-eruption condition with signs of termite damage and/or corroded corrugated sheet metal (Figure 4.9).

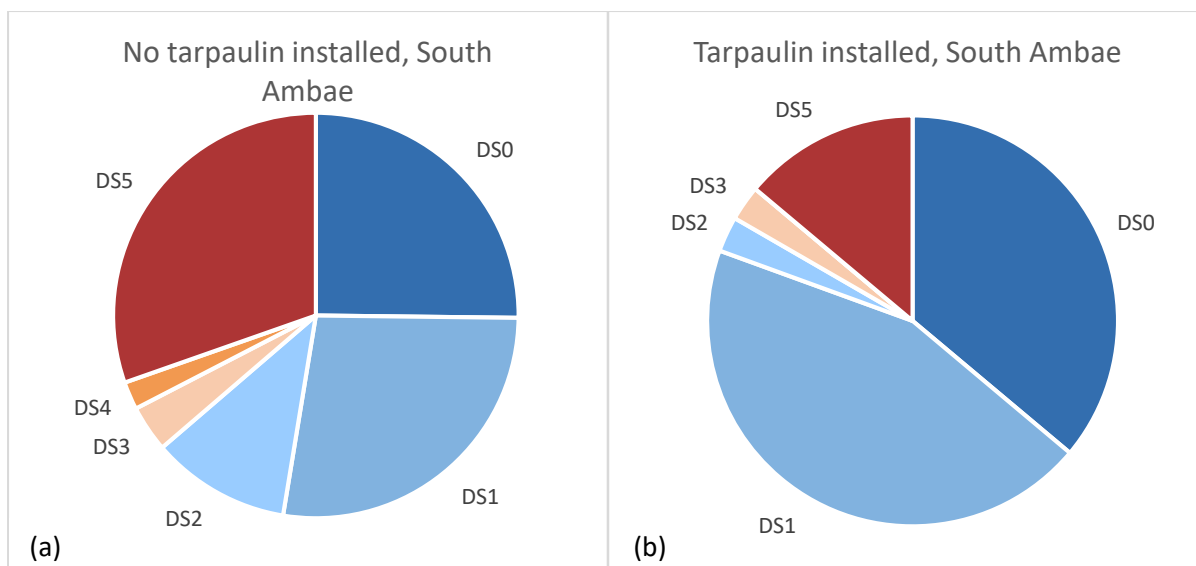
Most traditional buildings that had been installed with tarpaulins were observed in South Ambae (Table 4.5). Of the 171 traditional buildings surveyed in South Ambae, 21% (n=36) had a tarpaulin installed over the thatch roof (Table 4.5). Buildings in South Ambae installed with tarpaulins had a smaller proportion (14% n=5) of structural roof damage (DS=4-5) than traditional buildings without tarpaulins (32%, n=44) (Figure 4.19). Traditional buildings in South Ambae with tarpaulins also had a noticeably larger proportion of no or minor non-structural damage (DS=0-1) than those with no tarpaulins (Figure 4.19). The proportion of traditional buildings with no damage is larger for buildings with tarpaulins installed (36%, n=13) than buildings without tarpaulins (25%, n=34). It is therefore inferred that the larger proportion of minor damage (DS=1) in traditional buildings with tarpaulins (44%, n=16) is the result of the roofs being able to shed tephra more easily reducing the tephra load on a building structure, minimising the building's vulnerability and preventing severe structural damage.

Figure 4.19 Distribution of the damage traditional buildings sustained in South Ambae (a) Traditional buildings with no tarpaulin installed on the roof (b) Traditional buildings with tarpaulins installed on the roof.

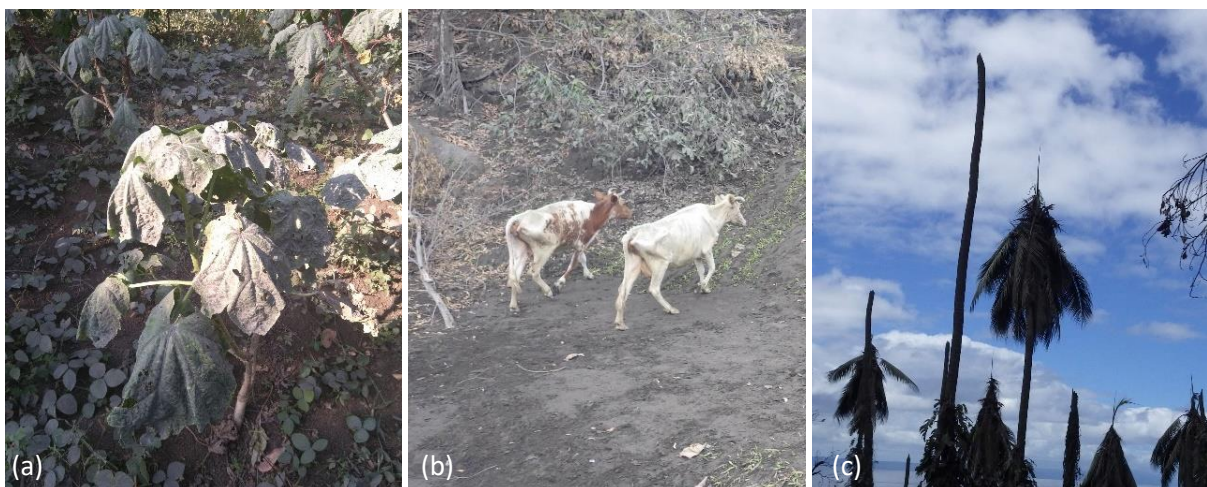
- Limiting photosynthesis capability of crops and pasture (Figure D.2a).
- Physical breakage, mechanical abrasion and burial of crops and pasture (Figure D.2c).
- Irritation of the eyes and skin of livestock, ingestion of tephra, respiratory issues and abrasion of teeth and hooves.
- Contamination to pasture and water for livestock leading to dehydration and/or starvation (Figure D.2b).
- Soil chemistry changes.

Figure D. 2 Agricultural impacts observed on Ambae. (a) Island cabbage damaged by tephra fall (b) malnourished cattle (c) damaged coconut trees

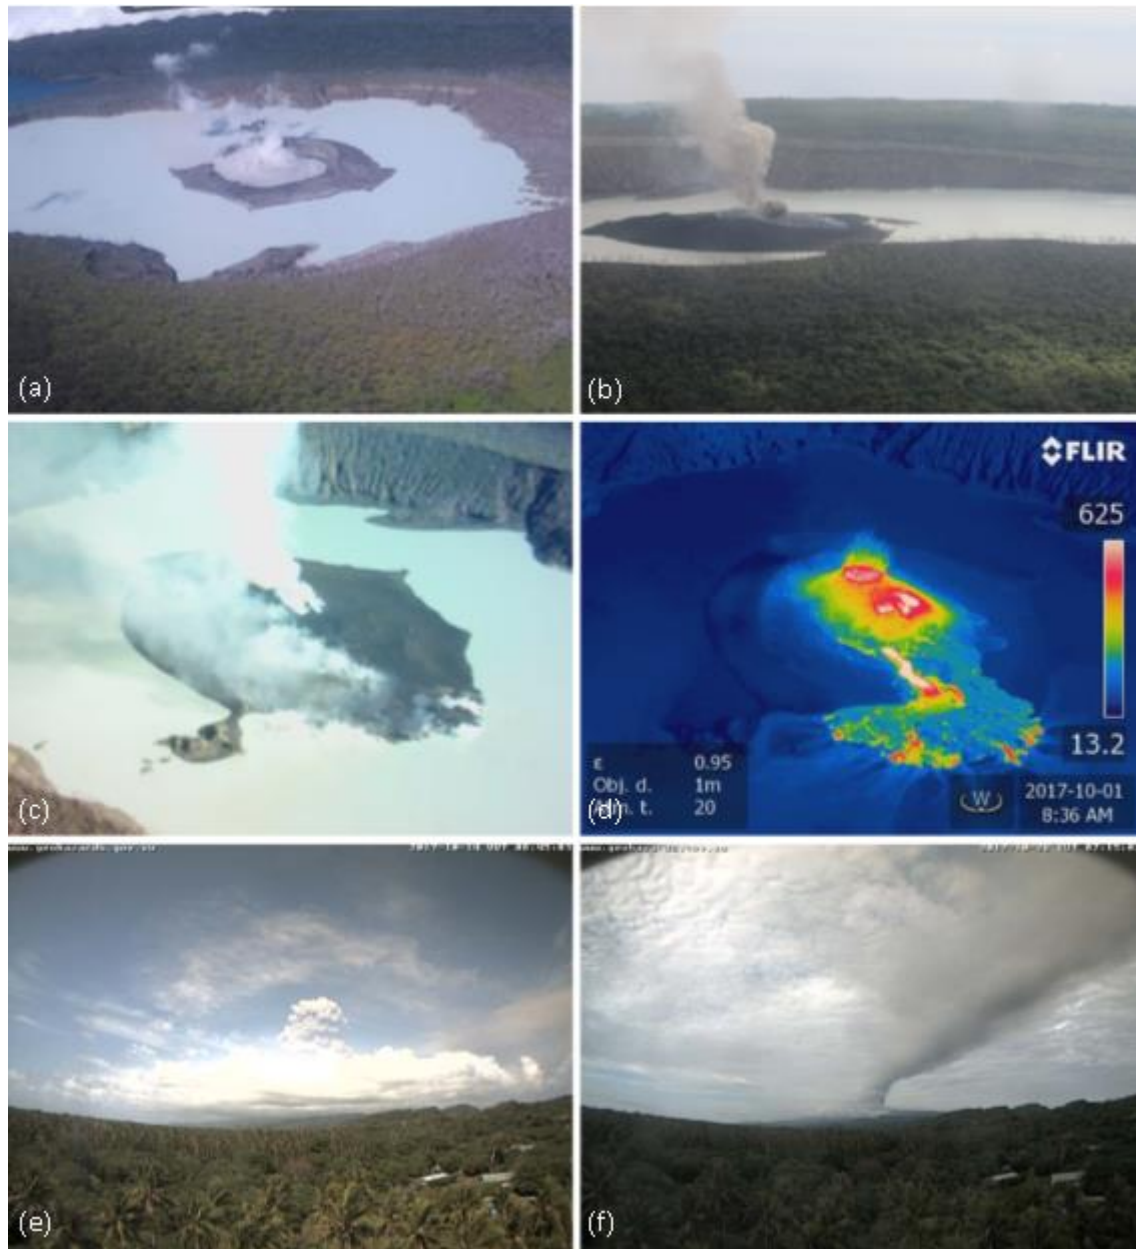
Impacts from the first eruption phase were to vegetation and water sources from tephra fall and acid rain; there were no reports of any building damage. Vegetation near the eruptive vent was stripped of all of its foliage, leaving only bare tree trunks (Figure E.1a). Further from the vent crops grown by families were damaged by tephra fall and acid rain to where some crops became unfit for consumption. Rainwater fed tanks used for drinking water were contaminated by tephra fall and acid rain when appropriate mitigation methods were not put in place to prevent tephra or acid rain from entering. While the primary cause of crop damage was attributed to tephra fall and acid rain, there were also indirect sources of crop damage reported by residents. The most common indirect crop damage reported was caused by livestock that had been released while people were evacuated off the island (Nimoho & Turot 2017). Other indirect causes of crop damage included the dry season, theft, pests and the lack of care while people were evacuated (Nimoho & Turot 2017).

Figure E.1 Series of photos showing the range of activity from Manaro Voui during phase 1 of its eruption period. (a) Pyroclastic cone in the centre of Lake Vui on 09/09/2017 (photo source: VMGD) (b) Pyroclastic cone that was growing from Manaro Voui's eruptive activity on 24/09/2017 (photo source: VMGD) (c) The pyroclastic cone and a lava flow that was flowing into Lake Vui 01/10/2017 (Photo source: Brad Scott GNS) (d) Infra-red image of the pyroclastic cone highlighting the lava flow 01/10/2017 (Photo source: Brad Scott GNS) (e) VMGD webcam view of an tephra plume from the eruption on the 14/10/2017 (photo source: VMGD) (f) VMGD webcam view of a tephra plume being carried down-wind from an eruption on 26/10/2017 (photo source: VMGD).

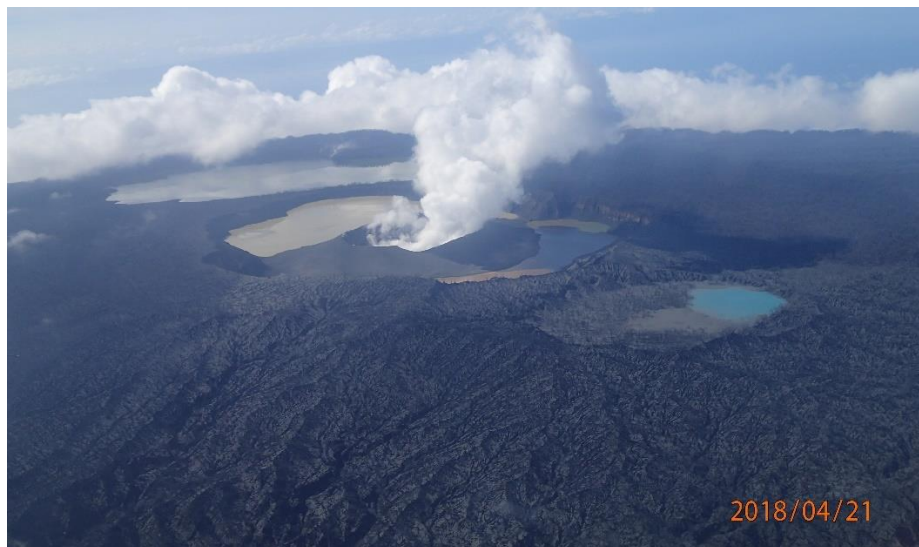
Tephra fall and acid rain hazards continued to damage crops and contaminate drinking water sources, but with the larger eruption events, the impacts were more severe than those previously experienced in the earlier two phases. The area of barren vegetation at the summit of Manaro Voui had grown substantially (Figure E.2) and smaller crops exposed to thick tephra fall were being completely buried in some areas. Trees loaded with tephra were falling under the weight of the tephra and in some cases fell across roads, restricting access around the island. Lahars and mudflows also caused disruption to accessibility around the island by blocking roads and making crossings impassable by vehicle. Buildings exposed to the thick tephra fall sustained damage from tephra loading. Damage to buildings ranged from no damage, minor damage and complete collapse. By April flights into Longana airport in East Ambae were cancelled.

Figure E.2 The summit of Manaro Voui during a VMGD observation flight on the 21/04/2018 note the pyroclastic cone had grown and split Lake Vui into two separate water bodies, Lake Manaro Ngoru nearly completely dried up and the extent of vegetation damage at the summit (Photo source VMGD).
